# National Transportation Safety Board

## Marine Accident Brief

### Allision of Tanker *Wawasan Ruby* with CSX Bayside Coal Pier

<b>Accident no.</b>	DCA-12-LM-025
<b>Vessel name</b>	<i>Wawasan Ruby</i>
<b>Accident type</b>	Allision
<b>Location</b>	CSX Bayside Coal Pier, Curtis Bay coal facility, Baltimore, Maryland 39° 13.30' N, 76° 34.57' W
<b>Date</b>	August 25, 2012
<b>Time</b>	1245 eastern daylight time (coordinated universal time –4 hours)
<b>Injuries</b>	One worker on the pier sustained moderate back and shoulder injuries
<b>Damage</b>	Pier: More than \$2 million; <i>Wawasan Ruby</i> : \$15,000
<b>Environmental damage</b>	None
<b>Weather</b>	Partly cloudy; good visibility; winds out of the east at 10 knots; air temperature 77°F
<b>Waterway information</b>	Baltimore Harbor, Curtis Bay, Curtis Bay Channel

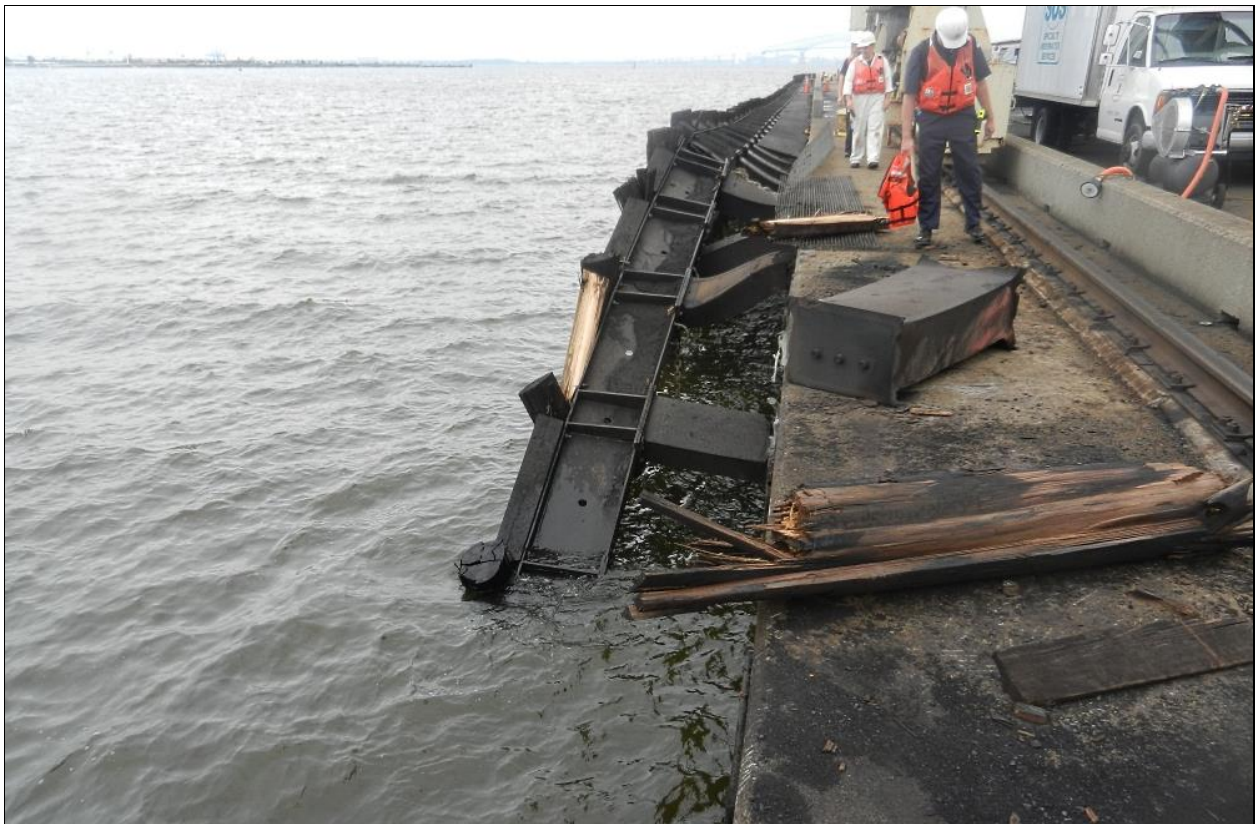
As the *Wawasan Ruby* approached the CSX Pier, no one on board the ship sounded the whistle to warn of the impending allision. Forward momentum carried the vessel's bow, particularly the bulbous lower portion, into the pilings under the dock of the CSX Pier. As the ship continued forward, it broke the pilings along a roughly 200-foot-long stretch until finally coming to a stop. The allision also damaged the pier's horizontal timbers, the fendering system on the dock, and the securing bolts and concrete. The upper part of the *Wawasan Ruby* bow struck and damaged the crane (loader) on the pier. A worker on the crane sustained back and shoulder injuries as a result of the allision.

**The CSX Pier after the allision. (Photo by the US Coast Guard)**

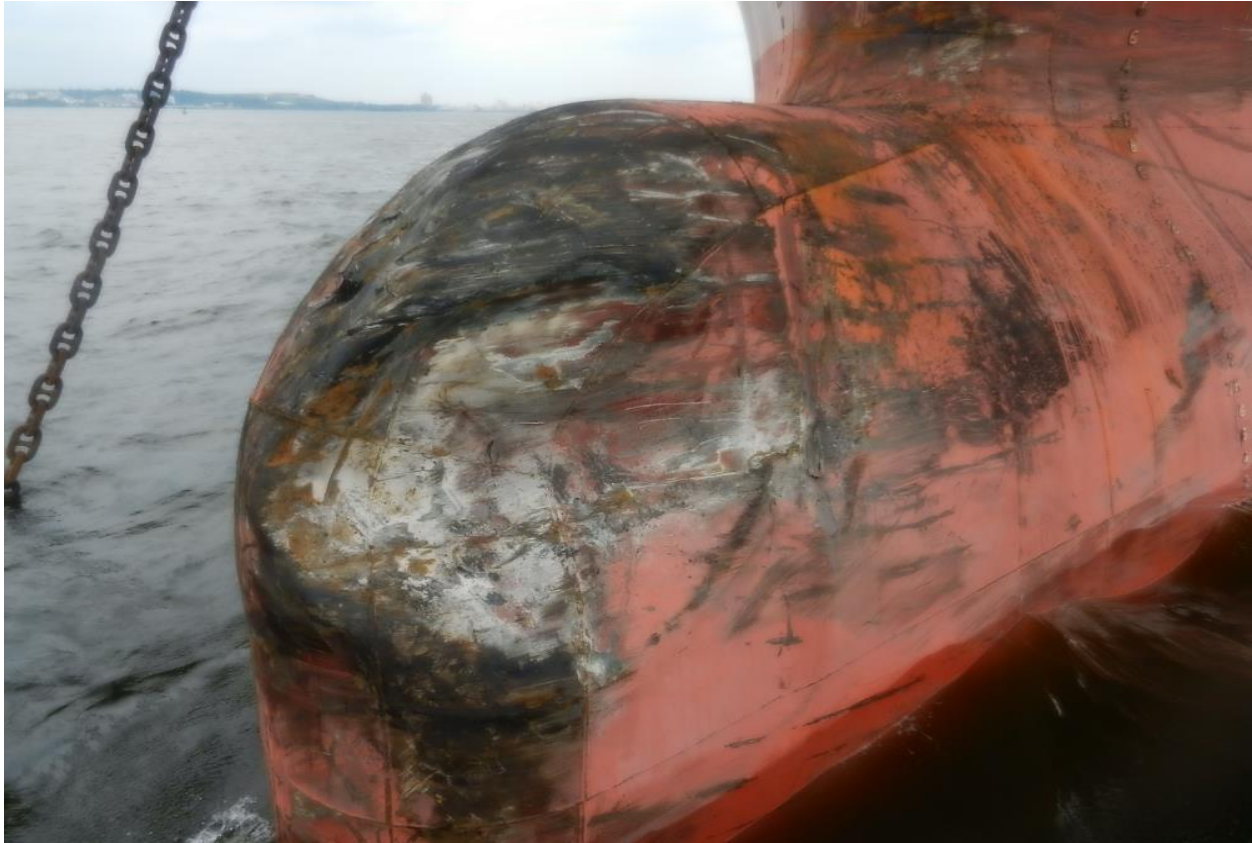
The damaged bulbous bow of the *Wawasan Ruby* after the allision. (Photo by the Coast Guard)
